RE: Site Inspection; ECDC Environmental, LC; ECDC Clay Mine; M/015/062; Emery County, Utah

Date of Inspection: November 19, 2002
Time of Inspection: 2:30 to 2:45 p.m.
Conditions: Mostly clear, 40's
Participants: Paul Baker, DOGM

ATTACHMENT
November 20, 2002
Photographs
M/015/062, ECDC Clay Mine, East Carbon Development Company

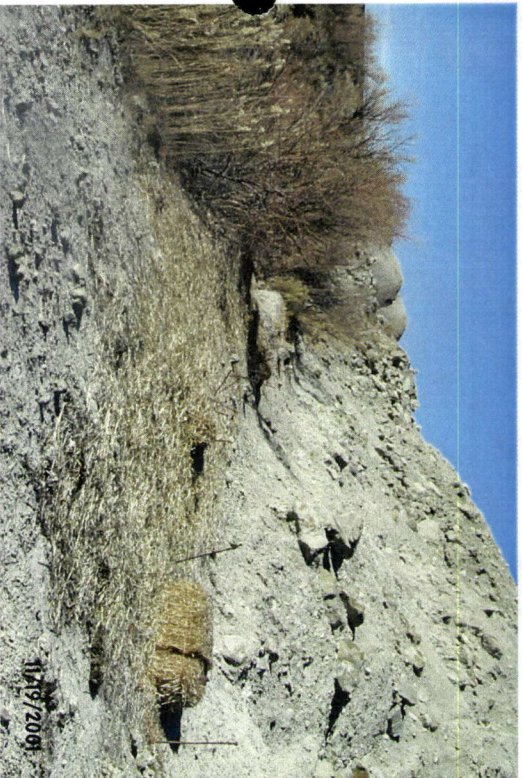
I saw little or no sign of erosion from the spoil pile through the trashed straw bales into the Price River. There may be enough rocks and soil crusting on this pile to reduce the amount of erosion.

Photo 1. What remains of the row of straw bales between the spoil pile on the right and the Price River on the left.

After seeing the lack of erosion from the spoil pile into the Price River, I believe it should not be necessary to maintain the row of straw bales between the pile and the river. The Division and the operator should watch this area for signs of erosion and sedimentation problems, but it appears at this time that sediment control structures may not be needed in this area.

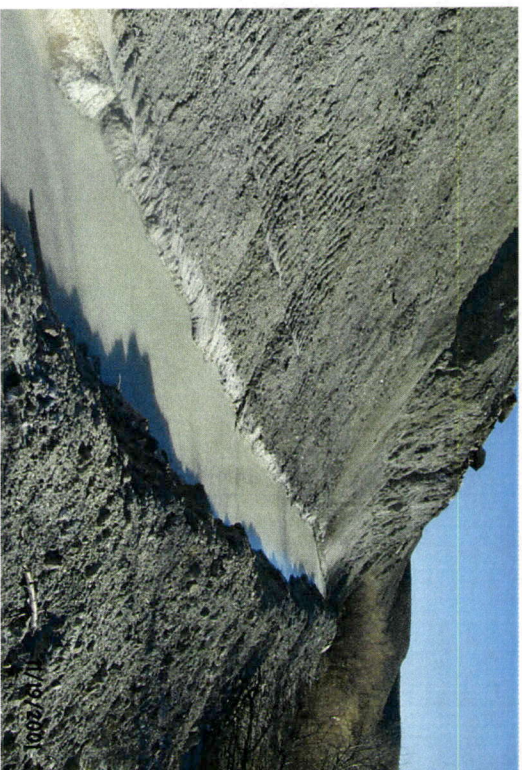
It appeared the site had recently (perhaps within the last month) had heavy rain and that some of the drainage and sediment control structures had been damaged, but these structures have been cleaned and/or repaired. There is a small channel with a culvert under the road as one enters the site, and it appears this channel and the culvert have been recently cleaned. Last year, the operator installed a line of straw bales between the Price River and what appears to be a spoil pile, and while most of these have been trashed by cattle (Photo 1), some of the remaining straw from the bales on the west end had been washed toward the river (Photo 2). Where these bales were washed toward the river, the operator has now built a berm that should keep all drainage from this area within the disturbed area. To the east of the row of straw bales, the operator last year built a berm, and this berm did not fail (Photo 3).

Photo 3. Berm to the east of the straw bales shown in Photo 1.

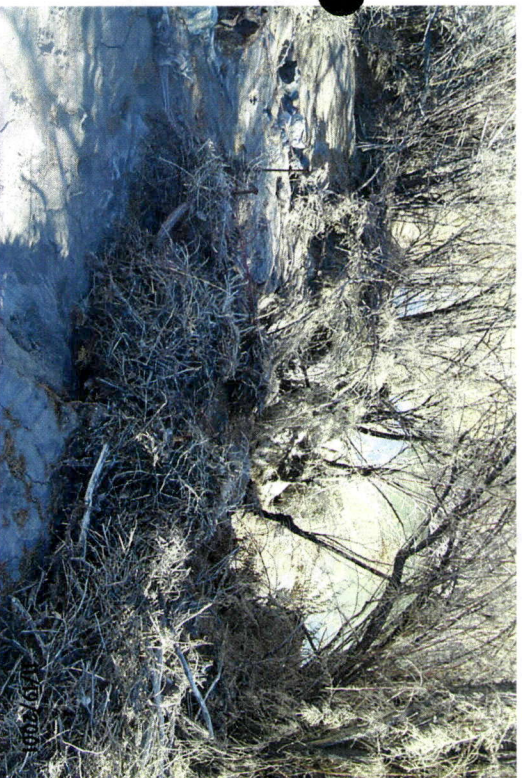
Photo 2. The west end of the straw bales where some were washed toward the Price River.
